Technical Note

T/N: OR-1

Date: May 1981

Use of Juniper Trees to Stabilize Eroding Streambanks on the South Fork John Day River

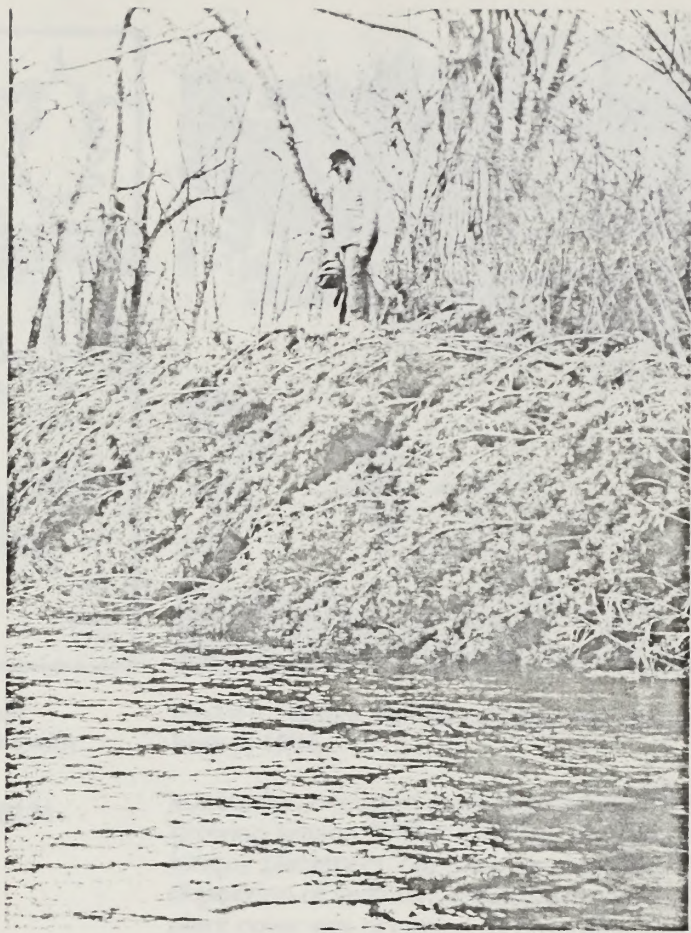
Figure 3 Completed work.

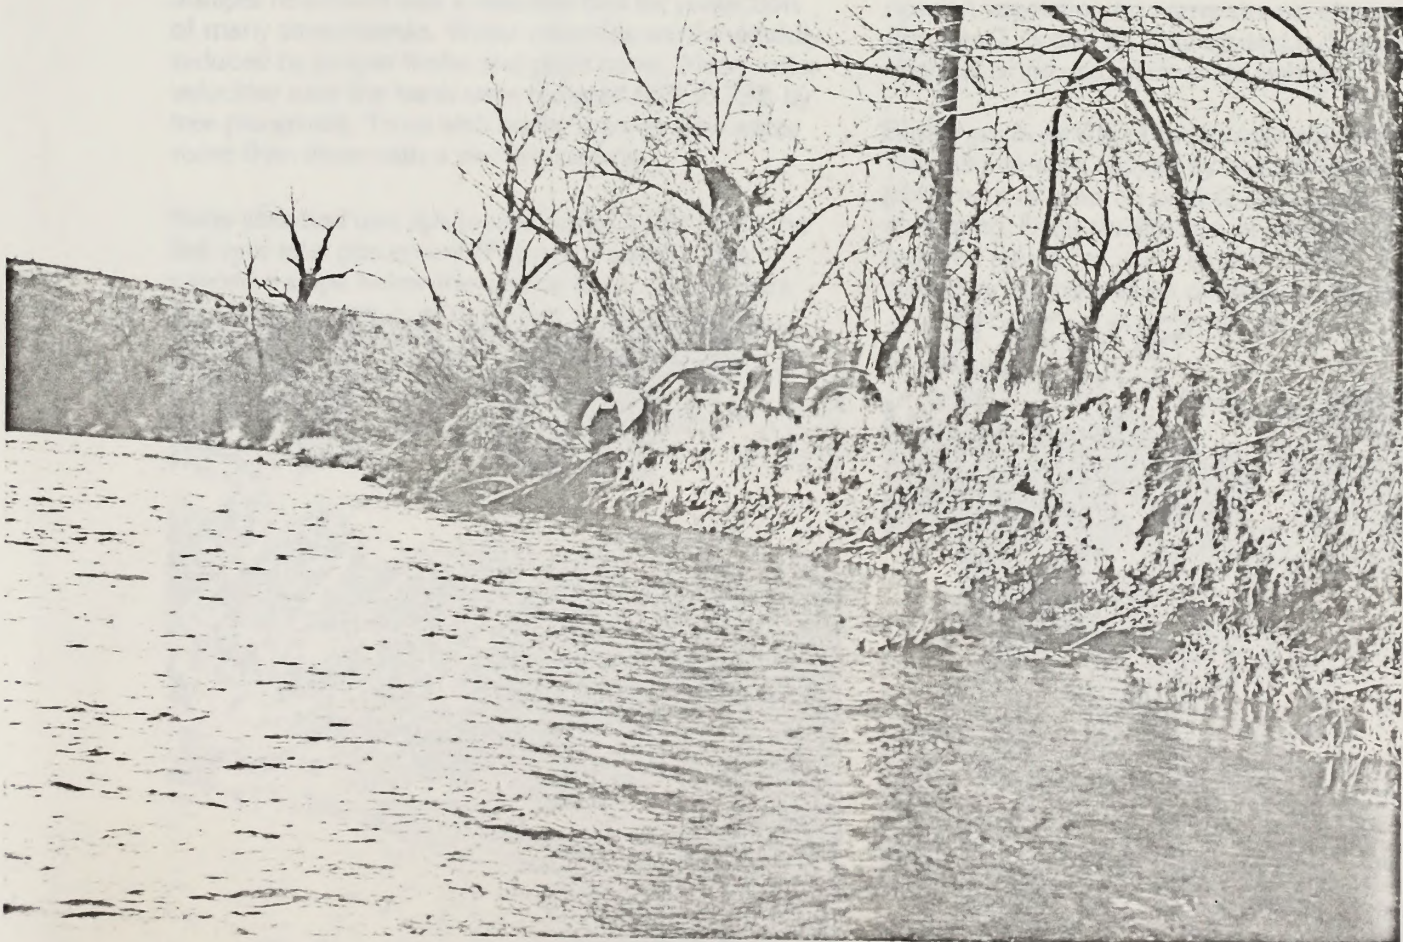
Tree size desirable for placement depends on the availability of equipment. Youth Conservation Corps crews used to place trees had difficulty handling trees over 6 inches dbh by hand. Tractors made the handling of larger trees possible (Figures 2 and 3). Trees with a bushy or heavy crown are preferred over slender ones. Green trees should be used. Trees were placed about one tree per yard of bank. A 2 to 3 ton, tilt-bed truck with solid sideboards was most practical for hauling trees.

Figure 2 Tractor used in placing junipers on eroding bank.

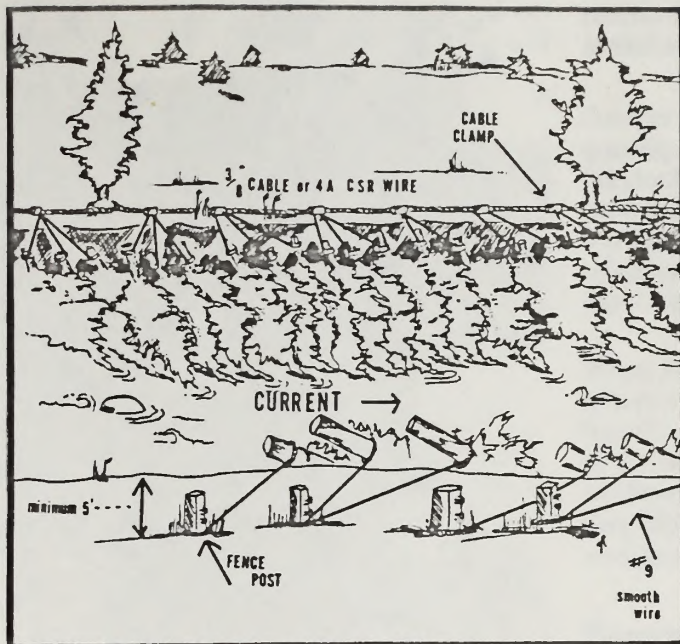
Trees should be angled downstream (Figure 4). Tree butts were tied with #9 smooth wire and attached to an anchor point. Fence posts and "dead manned" cable were used as anchors. Fence posts were driven to within 4 inches of the ground and wires tied tight. Fence posts should be at least 5 feet back from the bank. When cable is used, the cable should lie flat on the ground to reduce the tripping of large grazing animals and humans. Scrap power line wire (4 CSR wire) was donated by a local electric cooperative and used extensively in place of cable.

Figure 4 Juniper Placement Methods. Fence post anchors were 5½' posts cut in two pieces. The end with the soil plate was 24" long.

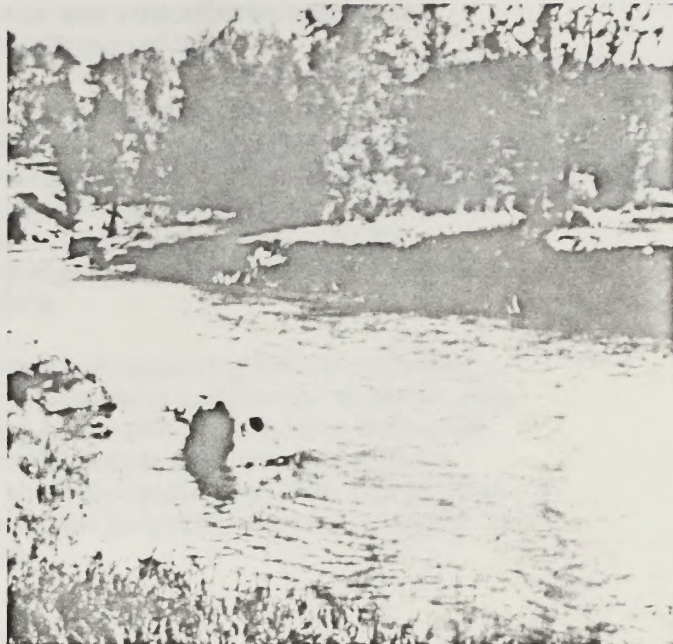
Many sites had tree tips buried under 2 feet of silt the first year after placement (Figures 5 and 6). This formed a slope below the vertical bank. Native plant

Figure 5 Before. Vertical cutbanks were present on far bank in 1976.

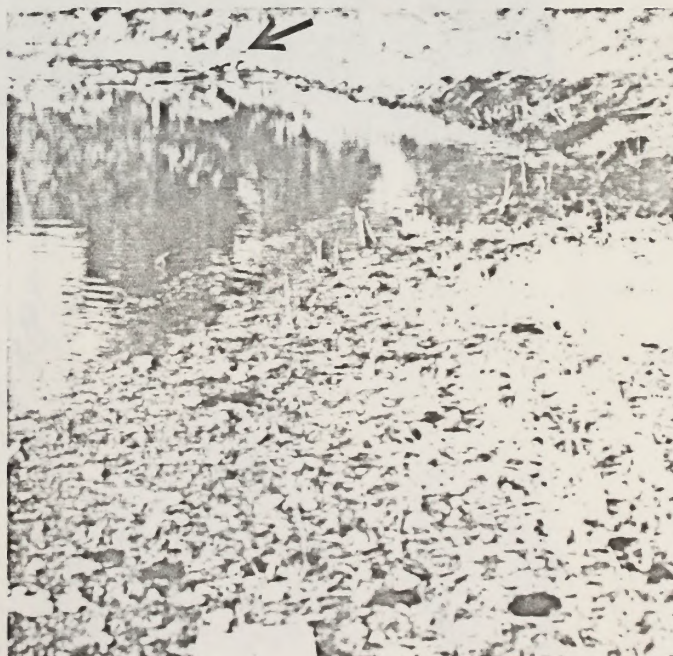
Figure 7 This area was devoid of riparian vegetation in 1973. Cutbank occurred behind the cow (see arrow).

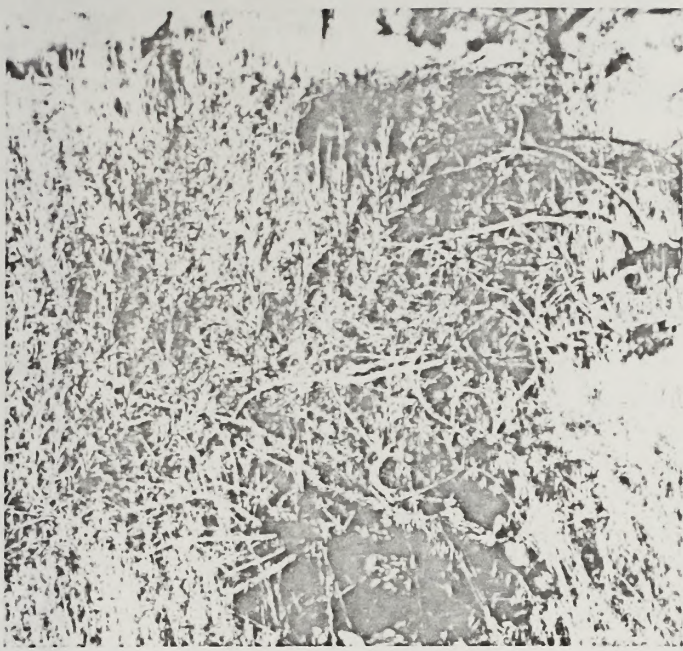
Figure 8 Closeup of cutbank shown in figure 7. Willows and herbaceous vegetation are established.

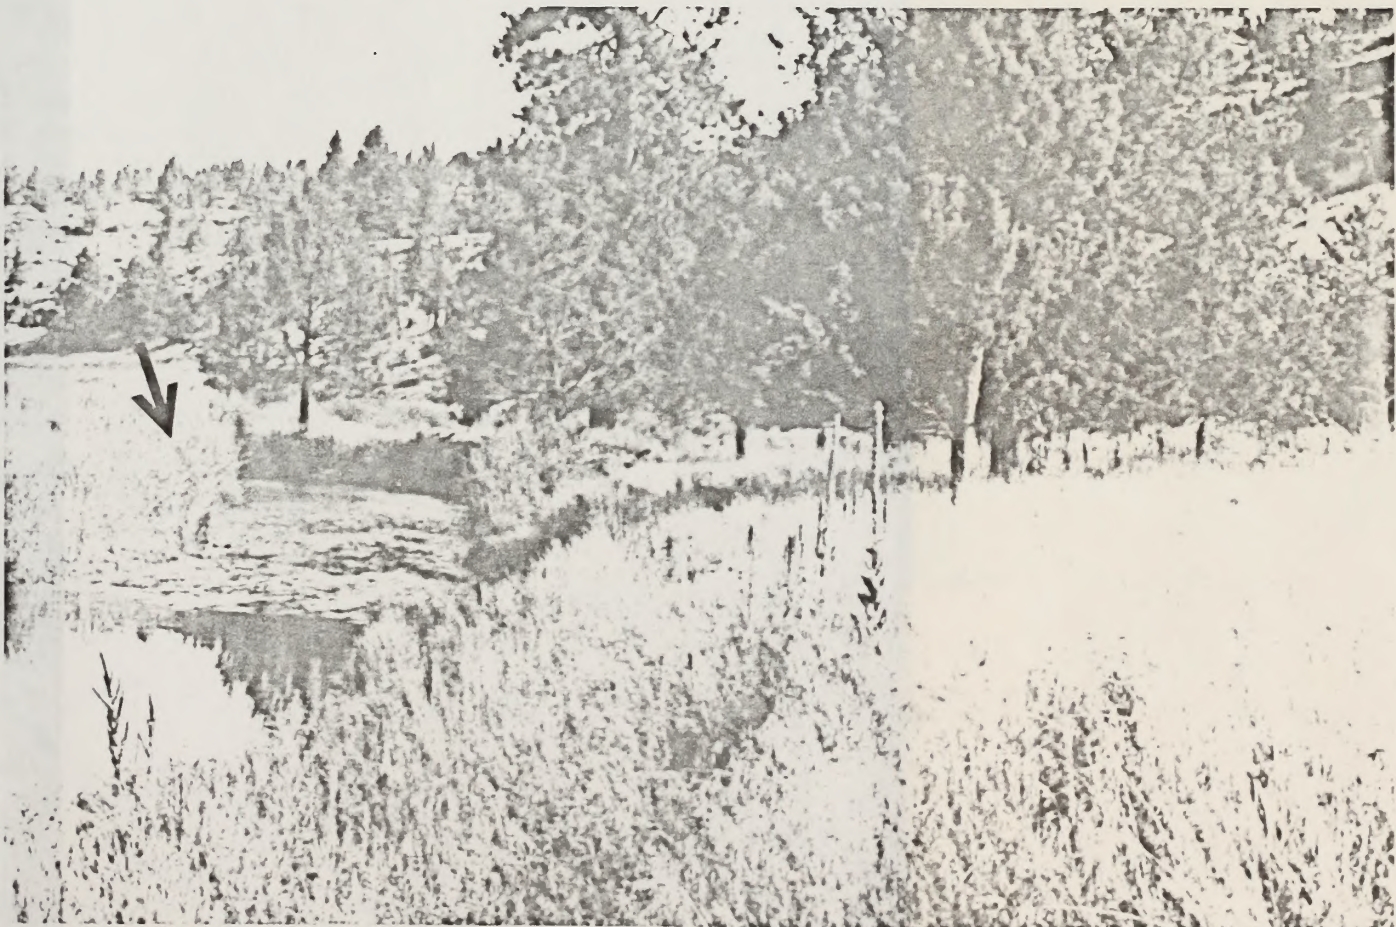
Figure 9 Photo taken during the summer of 1978. The same site as figure 7. This site was lightly grazed annually during the fall. Junipers were placed on the cutbank in 1977. Note encroachment of willows on left bank point bar (arrow). Point bar was bare of willows in figure 7.
